# Why your concrete structure fails again and again

**This article looks at the pervasive problem of corrosion induced failures that plague concrete structures in many environments. It describes the common methods of addressing corrosion that are employed by structural engineers and concrete restoration contractors. This is a big problem for owners and engineers around the globe – and it is particularly vexing for those structures that are situated in high salinity coastal environments such as condominium and hotel balconies, and structures that are exposed to de-icing salts such as parking garages and bridge decks.**

*Ted Huck, MATCOR, Pennsylvania, USA*

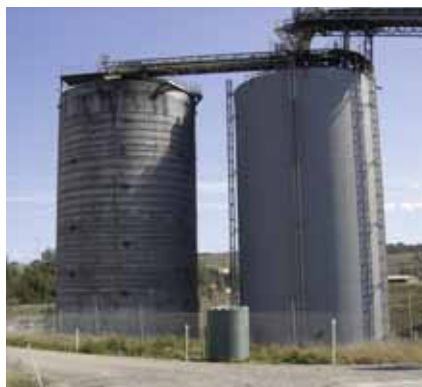
Figure 2: This before-and-after photo shows the silo on the left awaiting repair, while repair to the silo on the right had just been completed.

the complete exterior surface of each of the silo was then coated with an elastomeric anti-carbonation coating. Internal cracks were repaired with a polymer modified dry sprayed concrete.

Hydro-demolition was also used to prepare the concrete surface ready for the application of the carbon fibre strips. A pressure of about 83MPa applied using a rotary spray head was used to scour the surface and achieve the high bond strengths necessary for the successful application of the carbon fibre laminates.

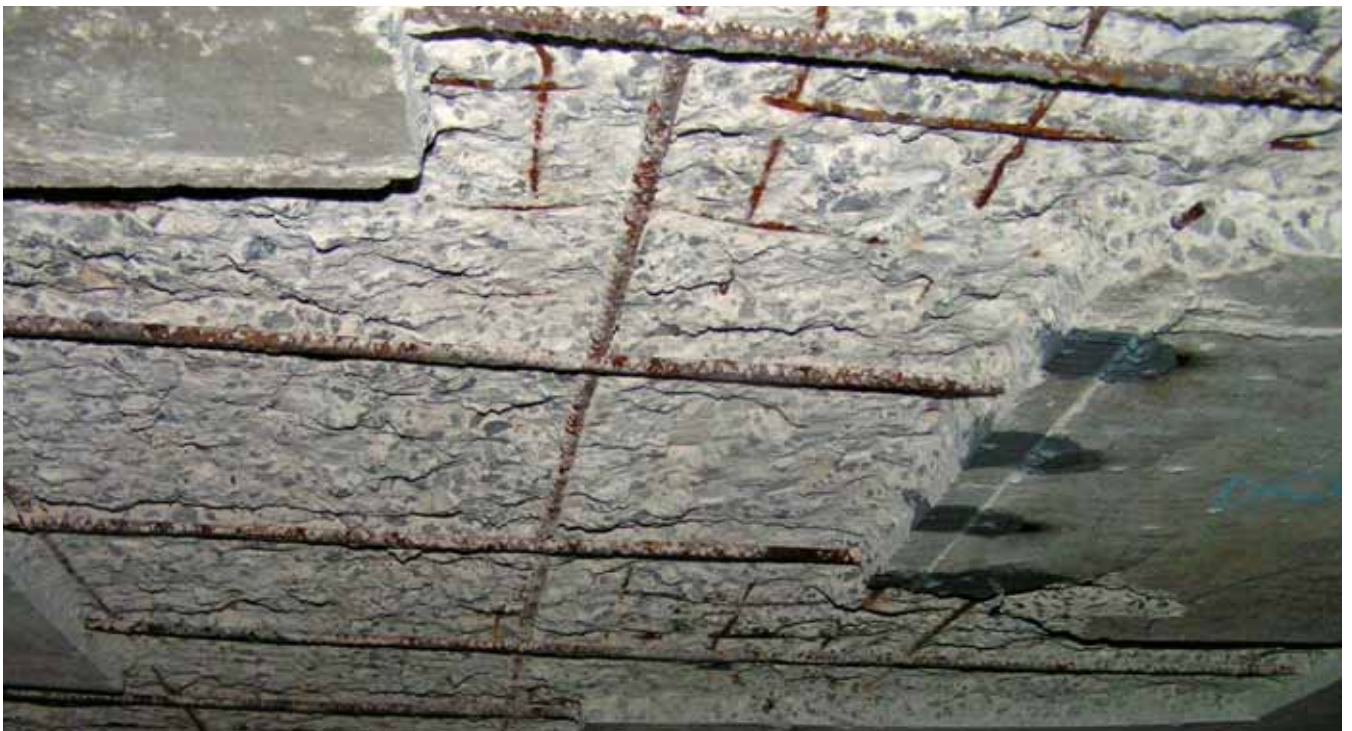
*Figure 2: Example of spalling and cracking due to concrete corrosion.*

steel, the reduced pH environment moves the steel from its normal passive state to an active corrosion state and rust begins to form. This reaction of the steel to form rust creates intense pressures as the steel expands five- to ten-fold in volume when it turns to rust. This causes delamination of the concrete, initiates cracking and eventually leads to spalling. Chlorides are ever-present in coastal environments and are commonly used as de-icing salts around the world. Chlorides can also be concentrated in many industrial cooling water applications and chemical processes.

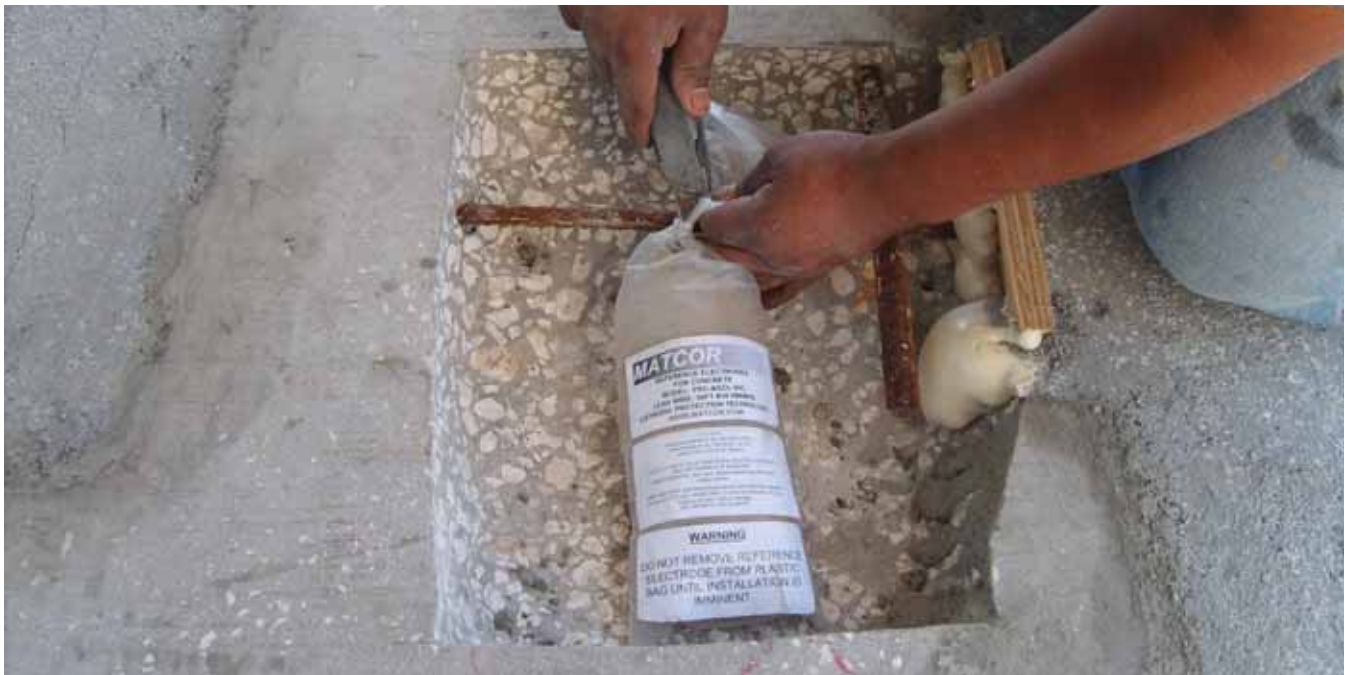
Figure 3: Reference electrode going into concrete repair patch.

The third proven strategy to address corrosion during a repair is to install an impressed current cathodic protection (ICCP) system. Cathodic protection applies a negative charge to the reinforcing steel, shifting the potential of the steel back into the passive range despite the presence of chlorides lowering the pH around the steel. Over time the chloride ions are actually repelled from the steel by the negative charge. The simplest and most cost-effective ICCP systems for many atmospheric applications use tiny wire anodes covered with conductive coatings that can be painted over the repaired concrete. A small transformer/rectifier converts AC power to DC power to provide the negative charge. Typically these systems use very little power – not much more than a conventional 120W electric light bulb for a typical condominium balcony.
