A CHARGED SITUATION

Ted Huck, MATCOR,
USA, discusses the
investigation and
mitigation of AC induced
corrosion.

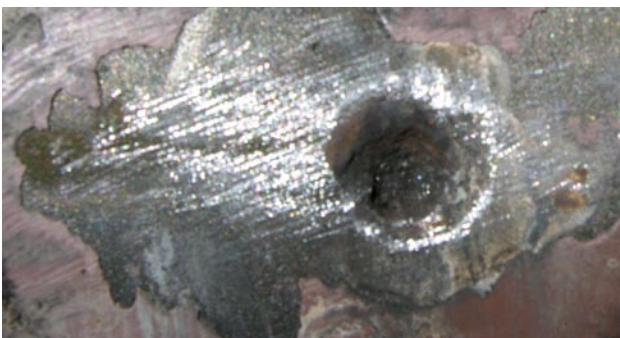
Figure 1. AC induced corrosion.

The corrosion affect of induced AC corrosion, however, is often not given sufficient attention. AC corrosion rates can range from 2 to 500 mpy with a typical value in the range of 60 mpy. AC induced corrosion can occur even when the AC voltage levels are well below the 15 VAC safety threshold cited by NACE. AC current density, soil conditions and holiday size all affect the corrosion rate.

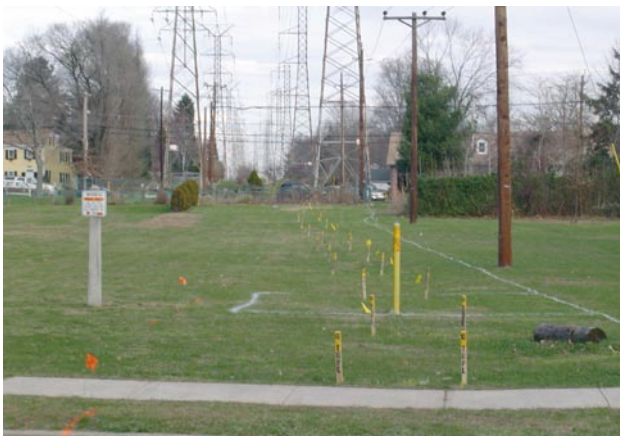
Figure 2. Congested right of way.

As areas become increasingly developed, land availability for utility right of ways are becoming scarce. The advantages of common utility right of ways are compelling. The area has been cleared of trees where power lines run above ground, creating a cleared highway perfectly suited for installing pipelines and other buried utilities. Telephone wires, fibre optic cables, water lines, natural gas and oil pipelines and electrical transmission lines are often forced to co-exist to supply required services to large industrialised areas supplying internet connections, sewer systems, cable television and fuel to homes, businesses and industry. From a land use perspective, this makes good engineering and economic sense, as the government can secure a single utility right of way.

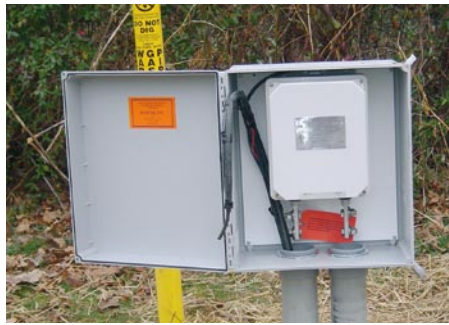
Figure 3. PCR installation.

Whatever approach is taken to dissipate the AC current, the effect on conventional DC cathodic protection systems is the same – they don't work well together. Placing a large current drain in the same DC circuit as the pipeline would render the cathodic protection system ineffective. Thus, the AC and DC systems must be 'decoupled.' Fortunately, the technology exists in the form of the PCR. These remarkable devices are installed in series with the AC current drain and allow AC current to flow while providing DC isolation of the current drain from the pipeline. Thus, effectively isolating the cathodic protection system from the AC current drain and allowing both the DC cathodic protection and the AC mitigation to work independently.
