HANDLING CATHODIC PROTECTION FAILURE

Ted Huck, Matcor, USA, delves into four strategies that can be taken when a cathodic protection system is no longer working.

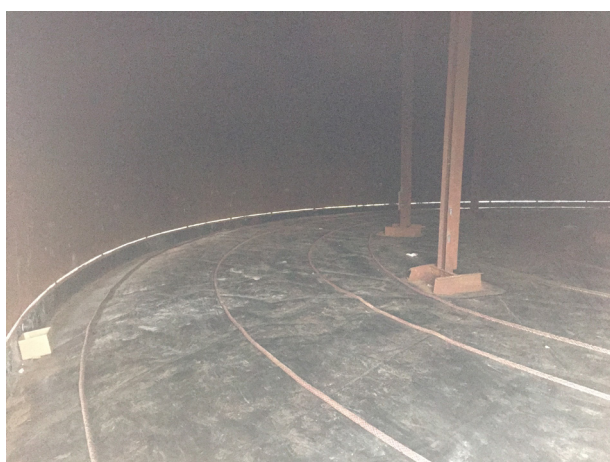
Figure 1. Concentric ring linear anode being installed on top of liner in a tank bottom replacement project.

If a tank has a non-conductive plastic sheet liner, the options to replace the tank CP system without replacing the entire tank bottom are quite limited. Any CP system replacement would have to be performed between the tank bottom and the liner. It is possible to lift the tank using air bags and cribbing to gain access underneath. This does require taking the tank out of service and can be both logistically challenging and quite expensive. Once the tank has been lifted, the CP system can be replaced (or in some cases repaired as needed.) Another alternative is to core drill through the ring wall and hydro jet new anodes in radially around the ring wall. This may slightly affect the integrity of the secondary containment system and is limited to tanks of about 50 m dia.

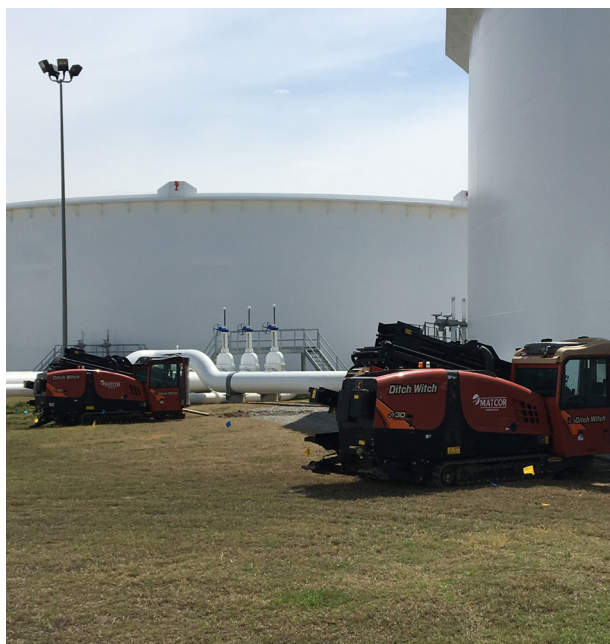
Figure 2. HDD drills boring under an existing tank to install new anodes.

- n Horizontal drilling of linear anodes under the tank.
- n Shallow or semi-deep anodes located around the tank perimeter.
- n Deep anode systems.

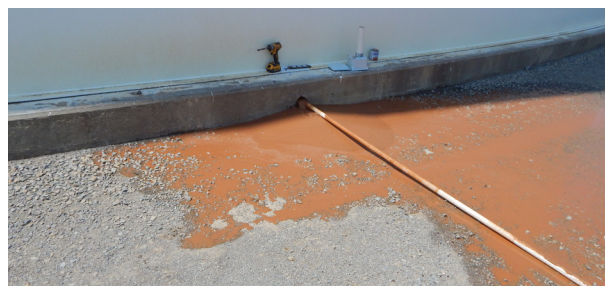
Figure 3. Hydrojet anode installation using a core drilled hole through the ring wall.
