# Pipeline Casing Repair and VCI Installation projects

Presented by Ted Huck, MATCOR Inc.

This presentation will discuss the development of a casing repair with VCI project scope, removing the short, sealing the casing and installation of the VCI product through the vent pipe.

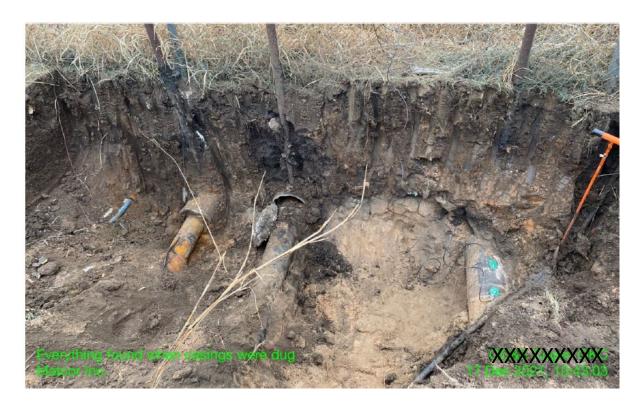
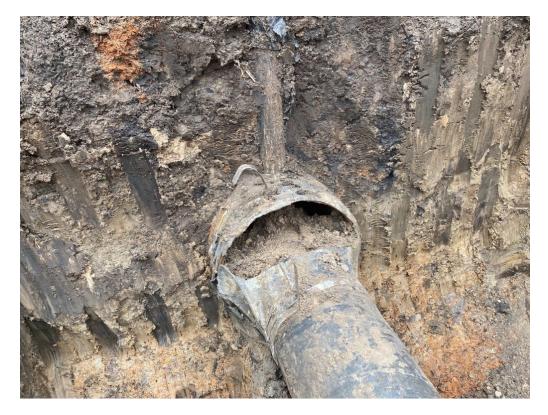
- Pipeline is a high-pressure Natural Gas line that runs under railroad tracks and feeds into a power plant.
- Pipeline had settled over the years and was not in contact with casing.

Adjacent to the natural gas line was the water and sewer lines. These lines were not being repaired per client.

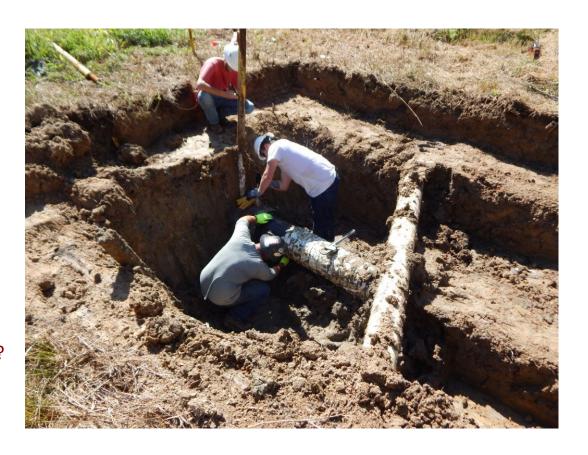
#### **Excavation process**

2023 Feb 22nd, Billings, Mt.

• Started vacuum excavating the soil around the pipelines, and potholed the lines approximately 20ft. back from the casing.

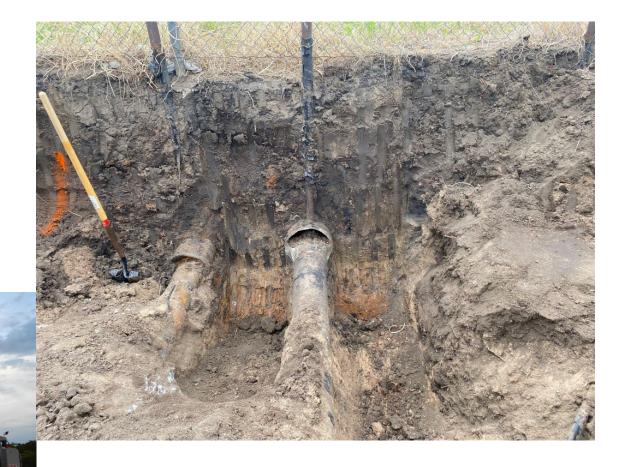
• Once pipelines were exposed, we use a mini-ex to remove soil back from the pipeline.

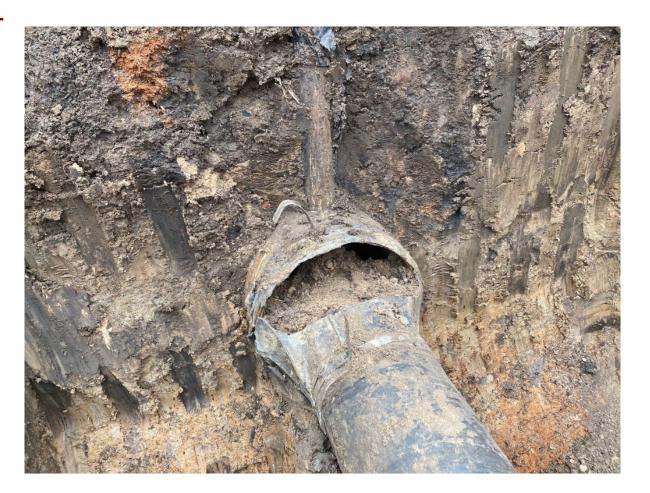
- Often the casing is filled with water or organic debris. This should be removed as best as possible before fixing the short.
- Luckily, that was not an issue on this project

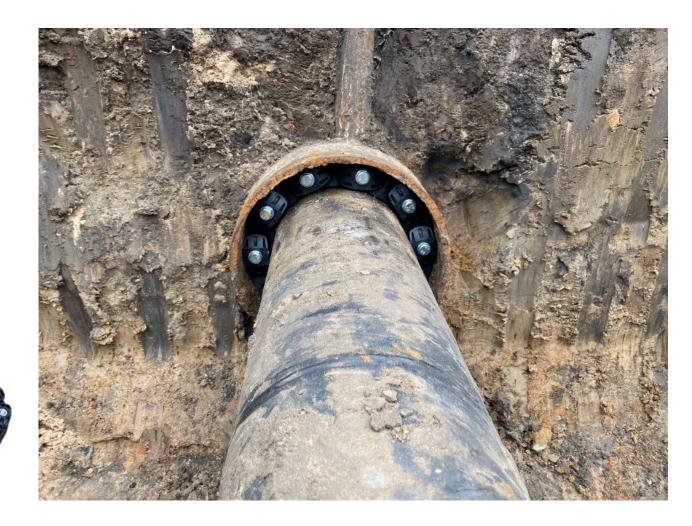
- Straps were wrapped around the pipeline and lifted with trackhoe bucket.
- Great caution is required when adjusting the pipeline. Only minor adjustments are recommended.
- Link seals should be installed with caution while carrier pipe is on tension.

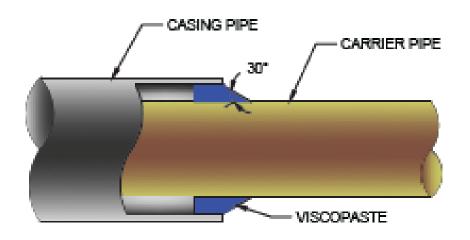
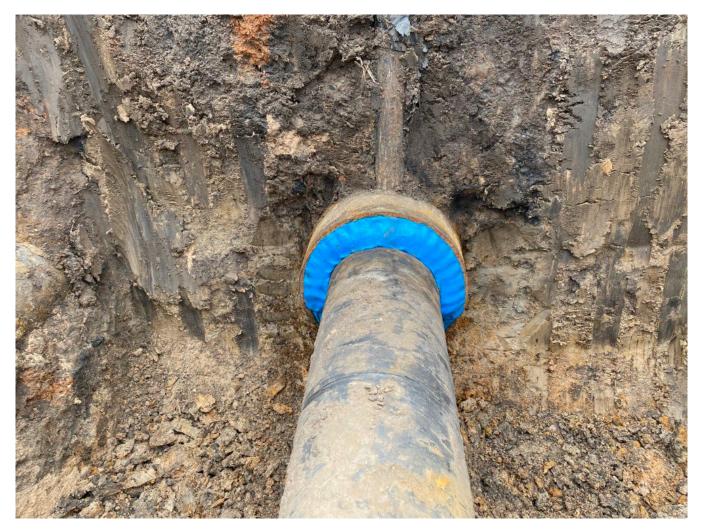
## Installation of Casing End Seal System - Installation of paste

- Caution is used to ensure area is clean and paste remains clean.
- Paste is pushed into the space as tight as possible

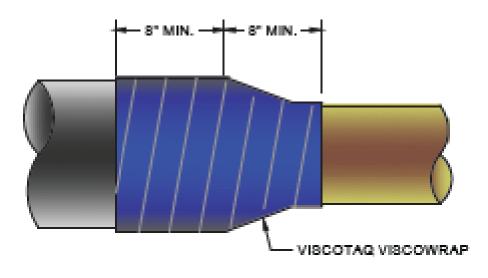
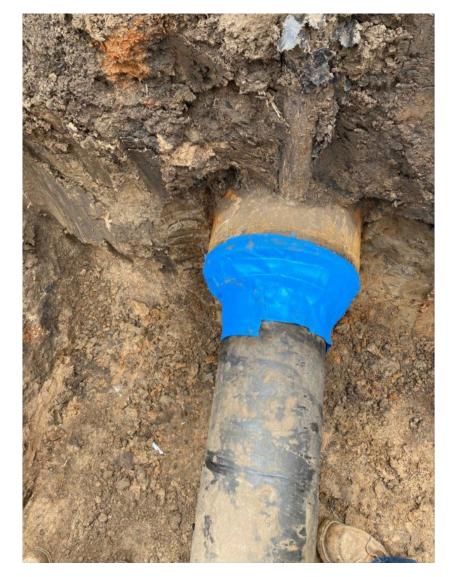
Wrap is applied starting on the casing and wrapped with 50% overlap

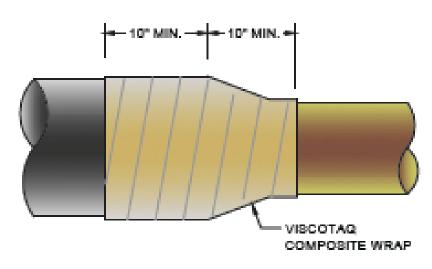
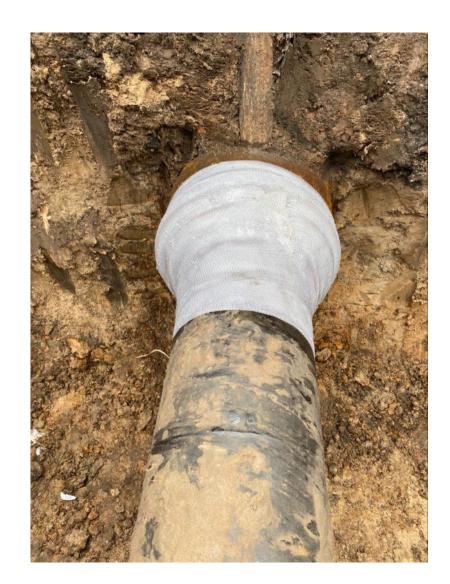
### Installation of Casing End Seal System - Installation of Glass Outerwrap

- Wrap is applied starting on the casing and wrapped with 50% overlap.
- Use water spray bottle
- Apply outerwrap as smooth as possible.

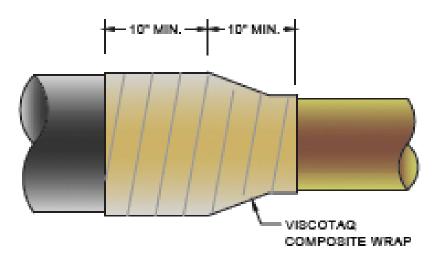
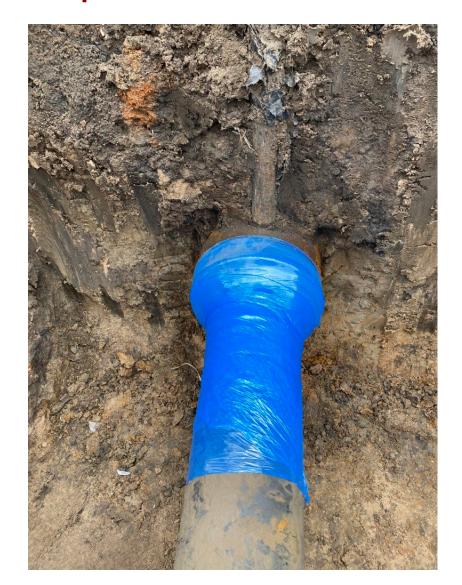
• Plastic wrap is applied over entire casing seal for curing.

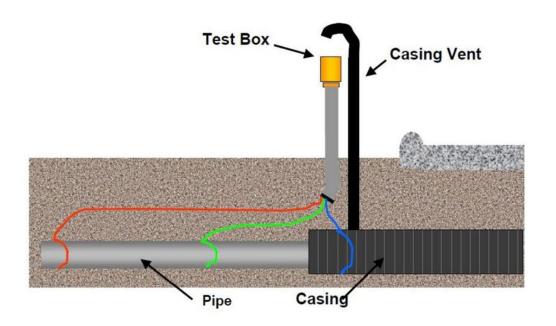
#### **Pipe Casing**

- Vents are often damaged or blocked.
- Often there will be restriction in the vent at the bend in the vent. This needs to be cleared before installation of VCI solution

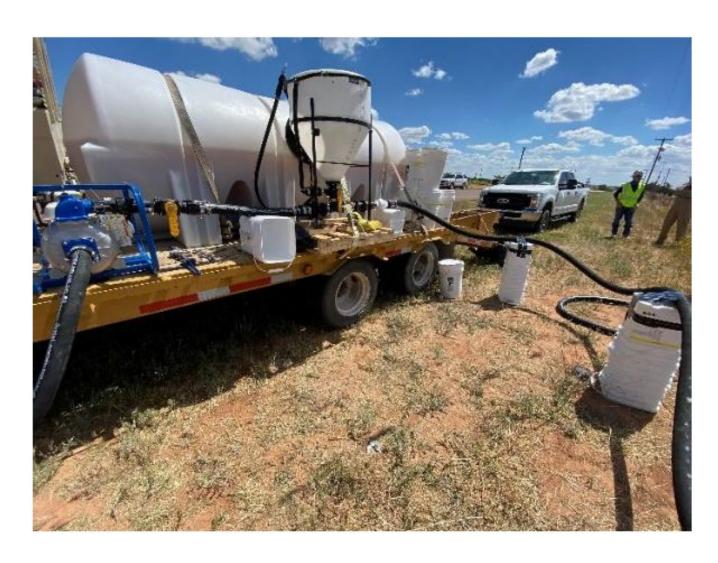
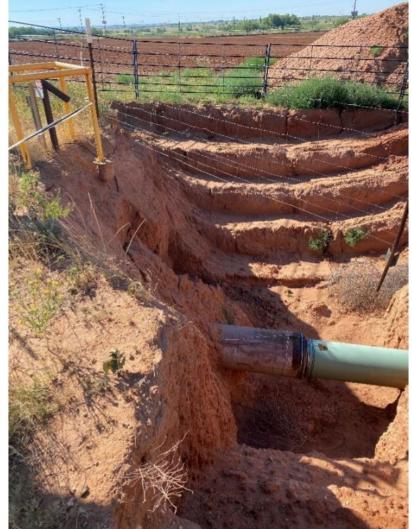
#### Installation of VCI solution

Enardo Series 900-SO vent valve is installed directly on the end of the vent line exhaust. Enardo's Series 900 has both pressure and vacuum relief capability.
