An age old problem

Ted Huck, MATCOR, USA, discusses the installation and application of linear anodes for rehabilitating ageing pipelines.

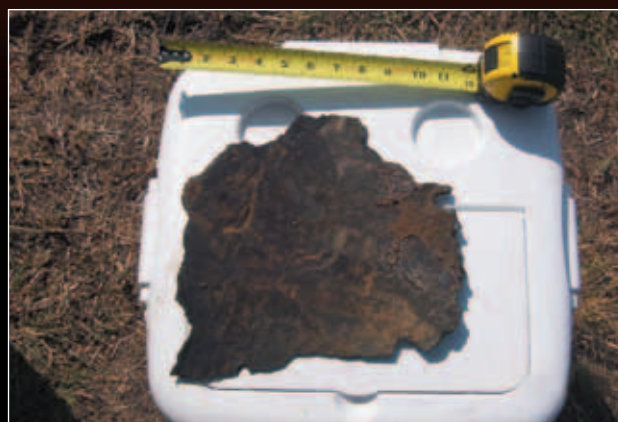
Figure 1. Coal tar enamel coating disbonded from pipeline. This sample was located close to the system rectifier.

Coatings that fail in a non-shielding mode do not prevent the flow of protective current to the pipe surface. This is typical of coal tar enamel and bitumastic/asphaltic coating systems. For these non-shielding coatings, upgrading the cathodic protection system to overcome the deficiencies of an ageing coating system is a viable strategy. Other coating systems that shield current from flowing to the pipe, such as tape coatings and polyethylene wraps, severely limit the

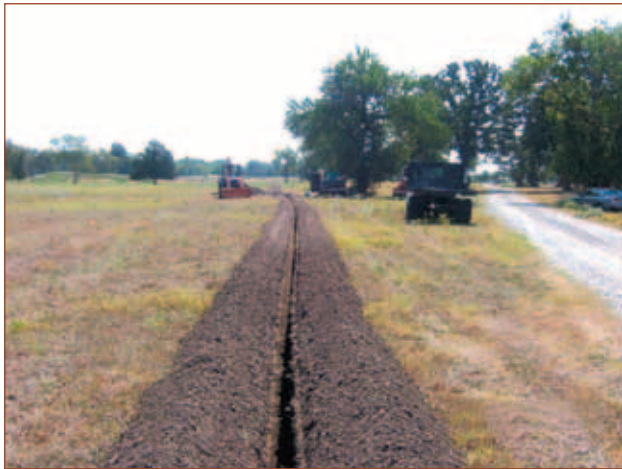
Figure 2. MATCOR SPL™-FBR linear anode installation using a trench unit.

The project installation was closely managed by Energy Transfer's personnel. The anode was located in parallel to the pipeline approximately 3 m off the pipeline centreline and at a depth of approximately 1 m. The anode installation was completed in two

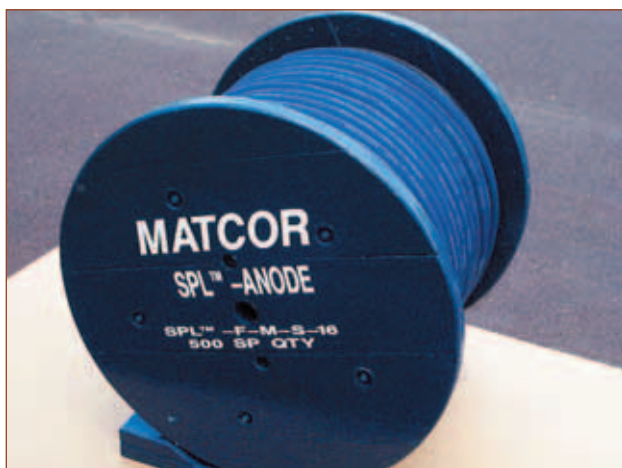
Figure 3. Linear anode supplied on a reel can be easily installed in the field.

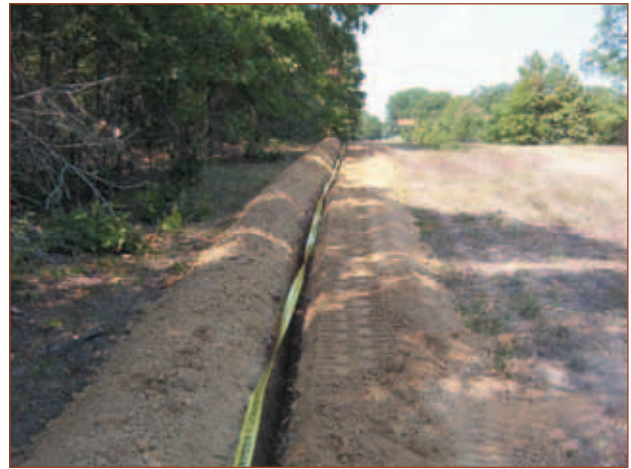
Figure 4. Linear anode installation complete with warning marker tape immediately prior to backfill.
