CORROSION NEWS **MATCOR**

A QUARTERLY PUBLICATION • SUMMER 2009 • WWW.MATCOR.COM

ECDA of Buried Pipelines – The Challenges Facing Today’s Pipeline Operators & Engineers

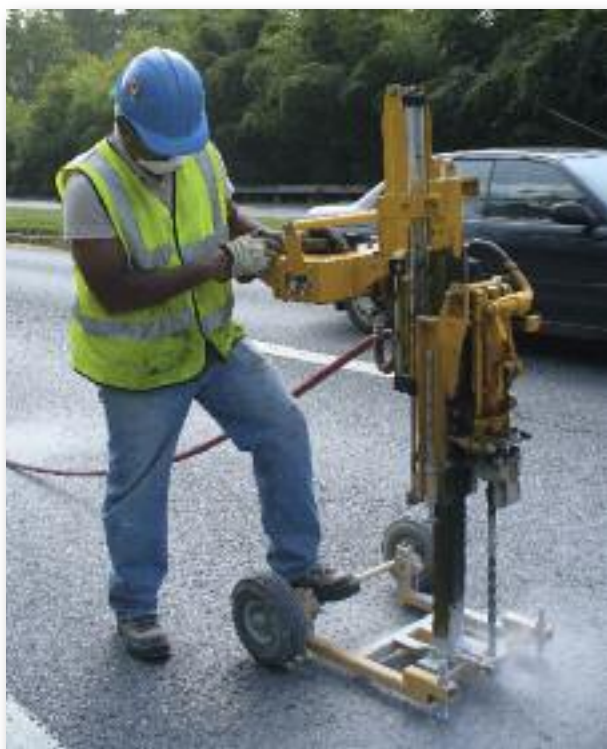
MATCOR made 1,550 holes in the road during the course of the ECDA.

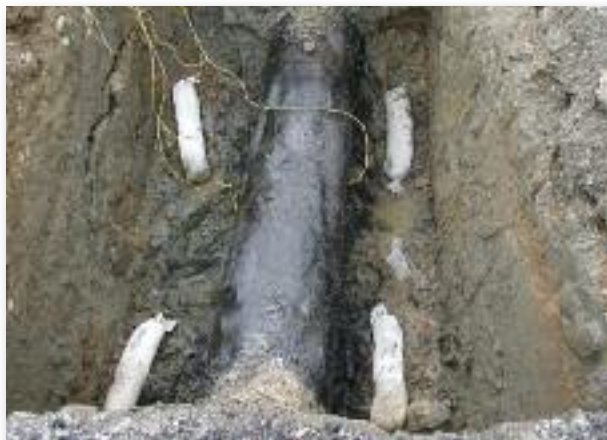
Magnesium anodes were installed along the buried piping as a preventive measure and to supplement the existing CP system.

becoming a future problem. The last excavation showed more serious pipe damage, requiring installation of split sleeves to act as reinforcements to the pipeline. Instead of simply re-coating the excavated pipe, the client took proper precautionary measures to maintain the integrity of the line, although they were not required to do so. Magnesium anodes were installed for additional protection at all three locations of excavated pipe.
