CORROSION NEWS **MATCOR**

A QUARTERLY PUBLICATION • WINTER 2007/2008 • WWW.MATCOR.COM

AC-INDUCED CORROSION – IT'S A REAL THREAT

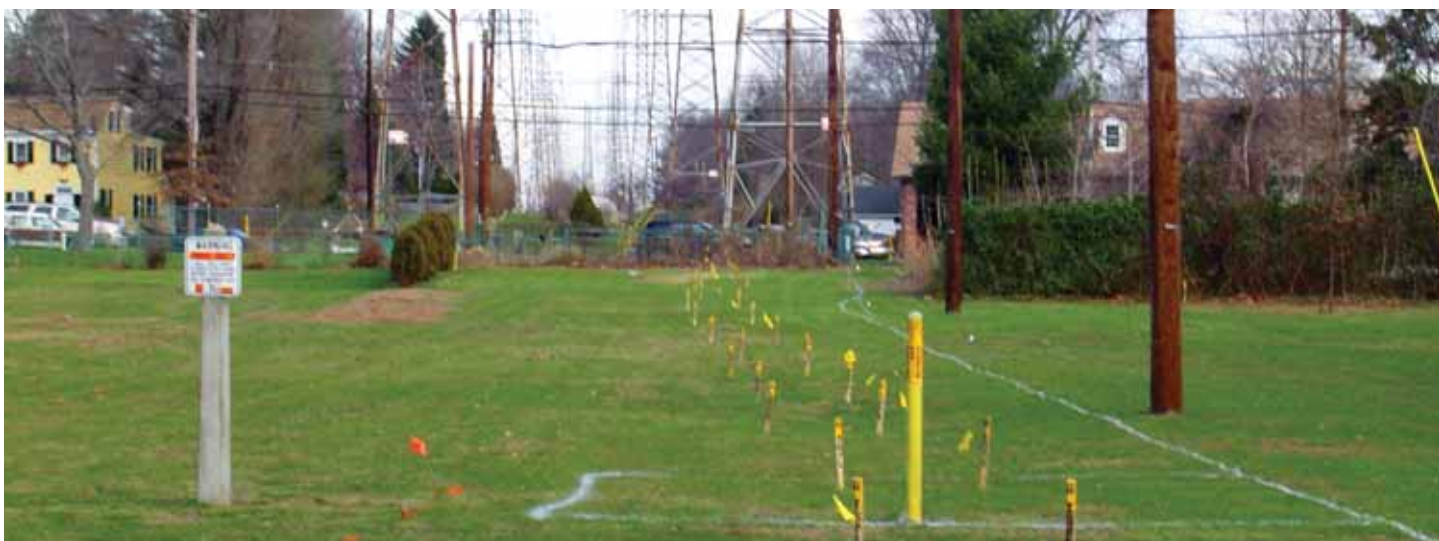
High power electrical lines were thought to have no adverse affect on pipelines buried beneath the lines. However, new evidence shows that the emergence of high-quality pipeline coatings has increased the incidence of AC-induced corrosion because the new pipeline has few coating defects to allow the current to dissipate to ground.

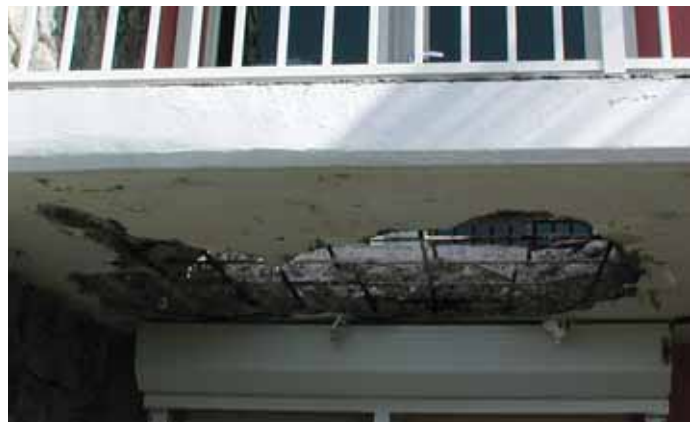
Corrosion of the rebar in concrete balconies, bridge decks, and swimming pools is a significant problem along the Florida coast. MATCOR's enhanced website has a tutorial on the causes of corrosion and cathodic protection, as well as the economics of the system that can help engineers explain the process to clients.
