# DRILLING FOR BETTER RESULTS

**Ted Huck, Matcor Inc., USA**, discusses a tank cathodic protection retrofit project in the Middle East that used horizontal directional drilling technology.

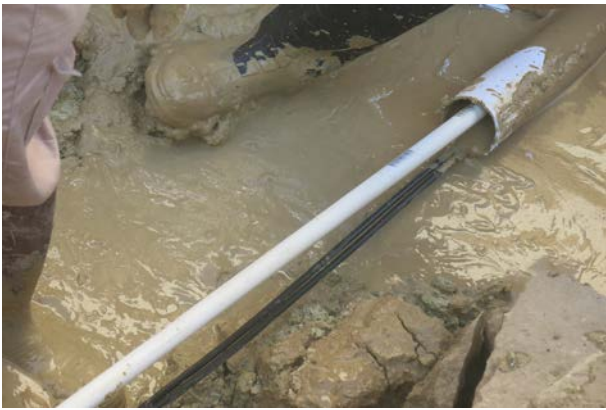
**Figure 1.** Anode and vent pipe assembly being installed in bore hole.

The anode system being installed consisted of a series of parallel slotted PVC pipes, which were bored into place under the existing tank. The slotted PVC pipes, once installed under the tank, allow for the insertion of the anodes. The anodes consist of a linear mixed metal oxide coated titanium wire connected to a parallel dual jacketed cable connected to each end of the anode and strategically along the length of the anode. The header cable jacketing is a combination of a tough high molecular weight polyethylene outer jacket and a chemically inert fluorinated PVDF inner jacket material. In addition to the anode, a small vent pipe is installed in the PVC pipe to prevent the build-up of any gases generated as part of the cathodic protection reaction at the anode. Finally, coke backfill is

pneumatically blown into the PVC pipe using a small tremie hose to fill the interstitial space inside the PVC pipe and to ensure good low resistance earth contact around the anode and assure a conductive current discharge path to the tank bottom through the pipe slots. One of the unique features of this design is that it is suitable for future anode replacement. The vent pipe can be used to fluidise the coke to allow for the extraction of the anode assembly at the end of its useful life and a new anode assembly can be reinserted in the PVC pipe.

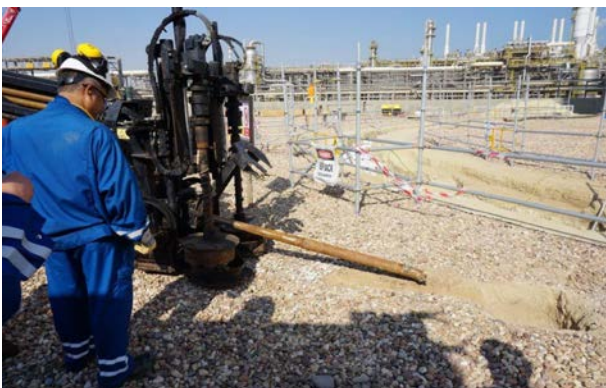
**Figure 2.** Horizontal directional drill bit commencing bore.

An alternate approach, which was successfully being performed in the US but that had not been tried previously in the Middle East, was the installation of multiple strings of linear anodes directly below the tank using horizontal directional drilling (HDD) technology. By drilling under the tank, it is possible to install multiple parallel anode strings under the tank spanning the entire length of the tank. This approach eliminates the concerns over current being discharged from the perimeter of the tank only protecting the outer edges of the tank and helps to ensure a more thorough distribution of current over the entire tank bottom. Another benefit of this approach is that a potential profile testing tube can be installed that allows for the installation of a testing device to be pulled along the entire tank bottom profile to measure the effectiveness of the cathodic protection system

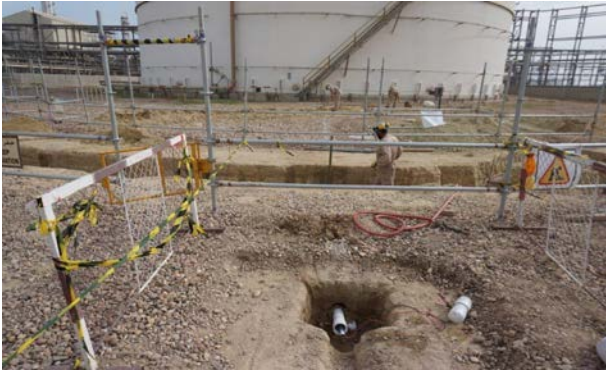
**Figure 3.** Potential profile slotted pipe and reference electrode assembly.

One of the biggest challenges with existing tanks being retrofitted with a new cathodic protection system is ensuring that tank potential readings can be made at the centre of the tank. Potential readings are used to measure the effectiveness of the cathodic protection system. For new tanks, it is common to install fixed reference electrodes under the tank to allow for potential readings. These fixed reference electrodes have a finite life, typically less than 20 years, and eventually they stop providing accurate data. Many new tank designs are now including monitoring tubes that allow for calibrated reference electrodes to be pulled through the tube to provide potential readings across the entire tank profile from one end to another. With the existing ethylene tank, the reference electrodes installed during the initial construction were no longer reliable and the only measurements that could be taken were from the perimeter of the tank, giving no indication that the centre of the tank was being protected. Along with installing the PVC tubes for inserting the anodes, a monitoring tube was also installed to allow for testing of the cathodic protection system across the full tank profile.

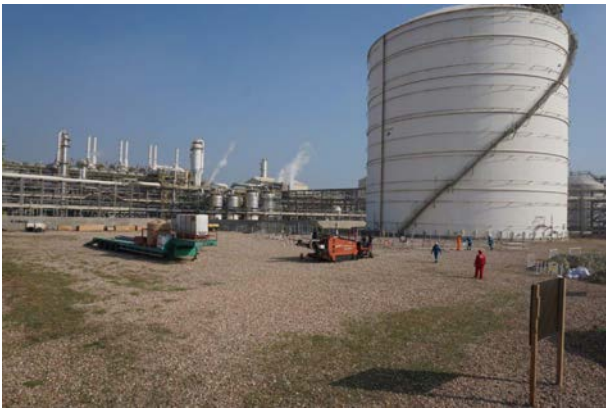
**Figure 4.** HDD drill rig and support equipment preparing for installation.

tank bottom. With today's sophisticated HDD technology, however, it is possible to put together a thorough installation procedure incorporating sophisticated drill head tracking systems to ensure that the drill head location was being continuously monitored throughout the bore. After reviewing the procedures and safeguards and carefully examining the qualifications and experience of the project team, the tank owner felt confident that the installation could be performed safely.
